Flightfax

ARMY AVIATION
RISK-MANAGEMENT
INFORMATION

JULY 1997 ♦ VOL 25 ♦ NO 10

Night accidents: a look at the numbers

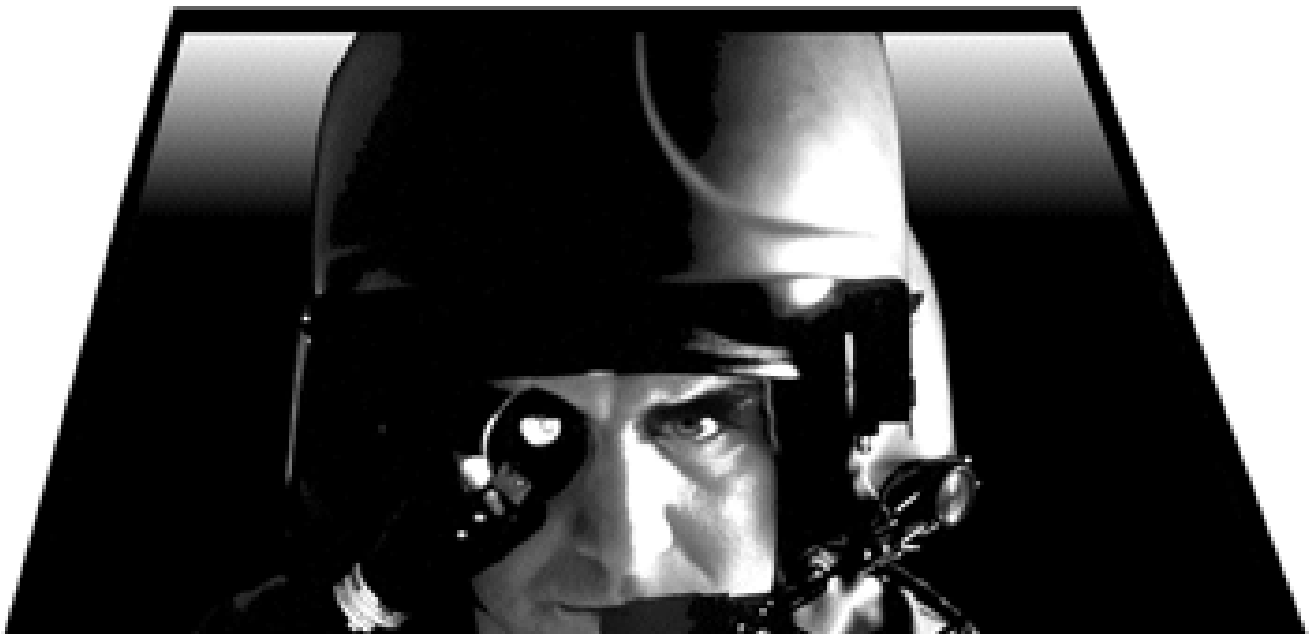
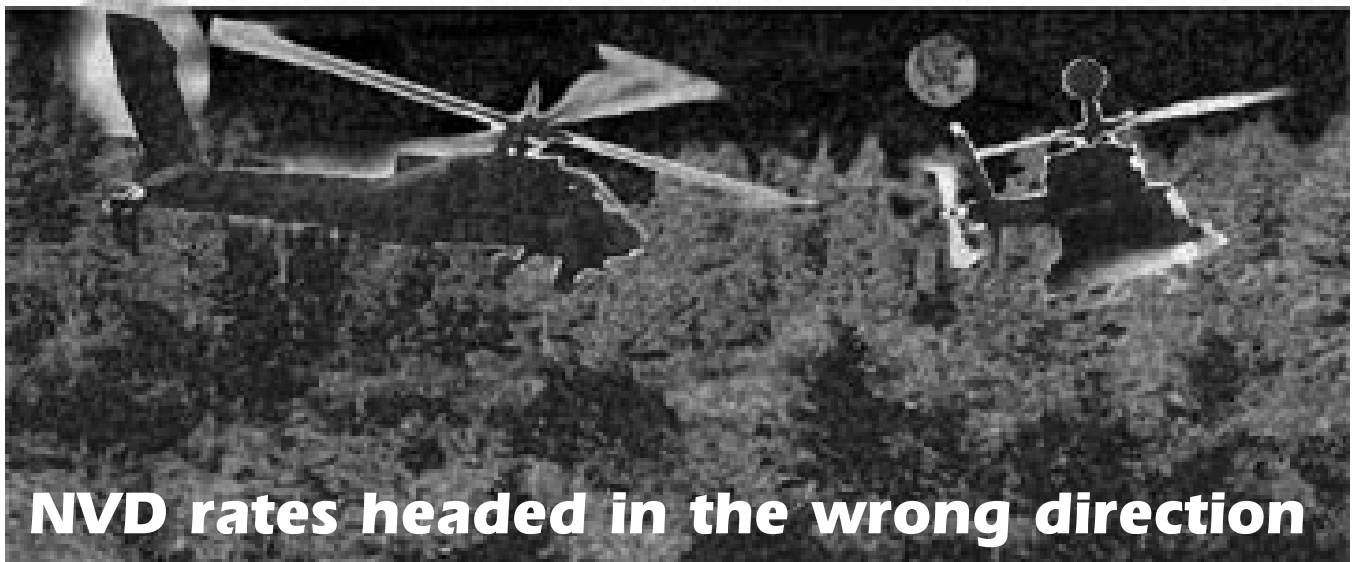
The tables below compare the FY 95 and FY 96 rotary-wing statistics. (Note: "Night systems" are the Apache PNVs/TADS. The comparatively high night-system rate is due, in part, to the relatively low number of hours flown for the year. The Apache had only one more Class A accident in FY 96 than in FY 95.)

Rotary-Wing Class A

Flight Accidents* FY 95 FY 96

■ Day	.50	.28
■ Night	2.02	2.77
Night unaided	1.27	0.00
Night aided	2.37	3.95
Night systems	6.39	11.27
Night goggles	1.46	2.39
Total	.86	.87

Rotary-Wing Class A-C

In FY 96, Army aviation achieved the safest year on record. The numbers are good news, and we all can justifiably be proud of the achievement. If, however, we dig into the numbers a little, not *all* the news is good. The bad news is that, overall, our night rates are headed in the wrong direction.

Our night rates are an indication that our night environment is a tough place in which to operate. They say we're doing tough, realistic training. They also say we still have a lot to learn. The positive side of this is that we're doing a lot of things right. We're flying a larger percentage of our total flying-hour program at night than ever before. We also fly aided almost three times the number of hours we fly unaided.
